**TRANSPORTATION SCIENCES CENTER
ACCIDENT RESEARCH GROUP**

CALSPAN ON-SITE AIR BAG/CHILD PASSENGER FATALITY INVESTIGATION
CALSPAN CASE NO. - ~~CA 94-43~~ CA 96 08
VEHICLE - 1995 HYUNDAI ACCENT
LOCATION - FLORIDA
CRASH DATE - ~~██████~~ 1996

16. <i>Abstract</i> <p>This on-site air bag deployment crash focused on the injury mechanisms for the fatal injuries sustained by a 3 month male passenger who was restrained in a rearward-facing Evenflo On-My-Way child restraint in the right front position of a 1995 Hyundai Accent. The driver of the vehicle was assisting the mother of the infant by following her to a auto repair service center for repairs to the mother's vehicle. Due to a leaky exhaust system, the infant's mother allowed the Hyundai driver to transport the infant in her vehicle and not expose the child to the potentially hazardous exhaust fumes. A third party assisted in the placement of the infant restraint in the right front position of the Hyundai. None of the adults were aware of the risks associated with the risks of rearward-facing child restraints and the deployment of passenger side air bag systems.</p> <p>En route to the service center, the driver of the Hyundai initi

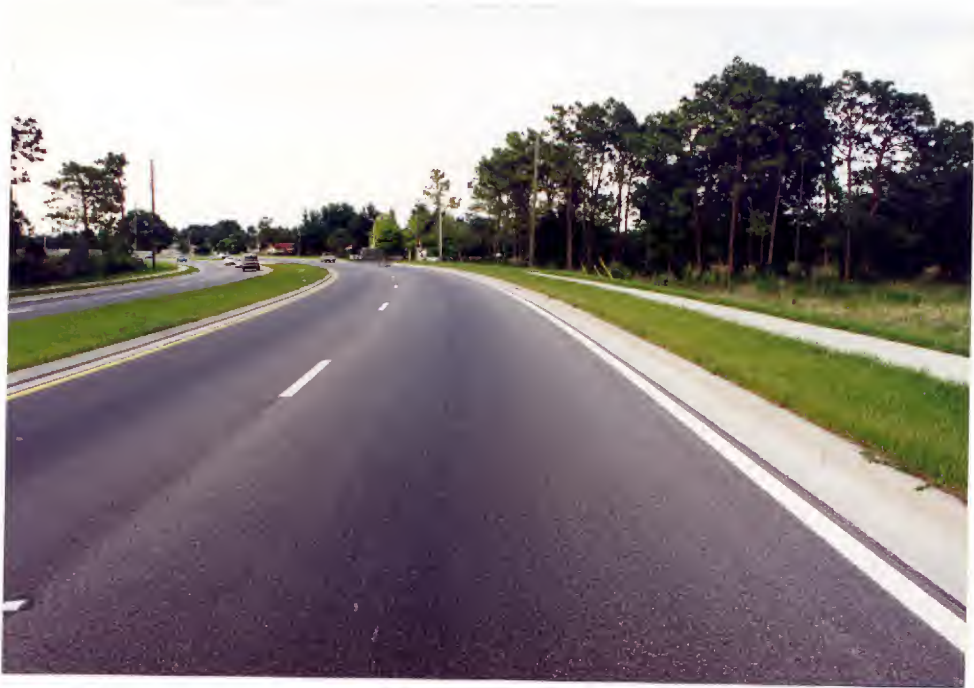
1. Pre-crash trajectory of the 1995 Hyundai Accent.

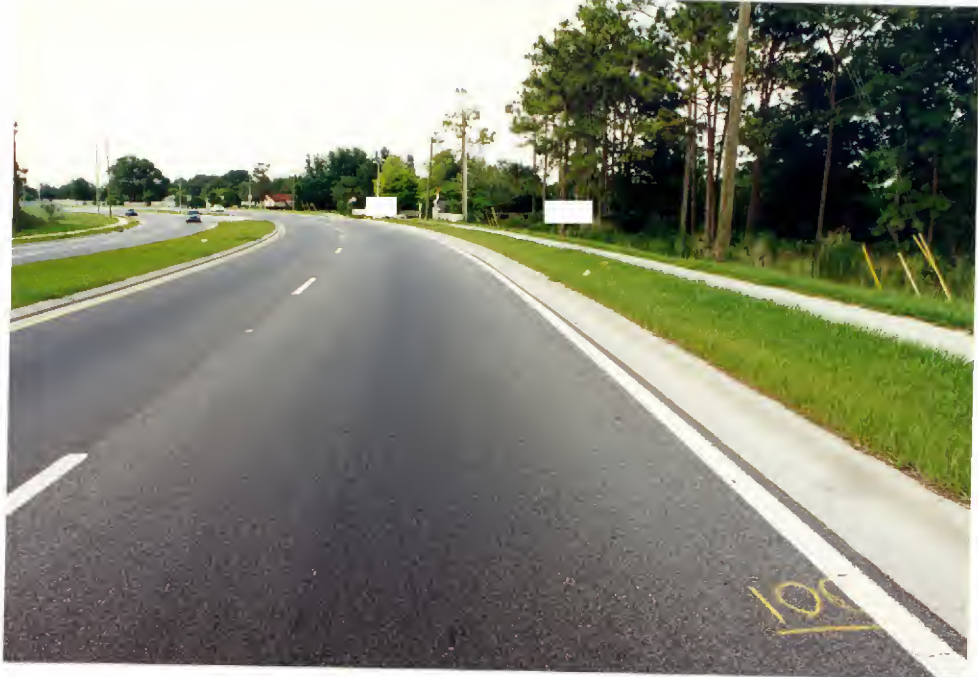
3. Area where evasive action was initiated by the driver of the Hyundai.

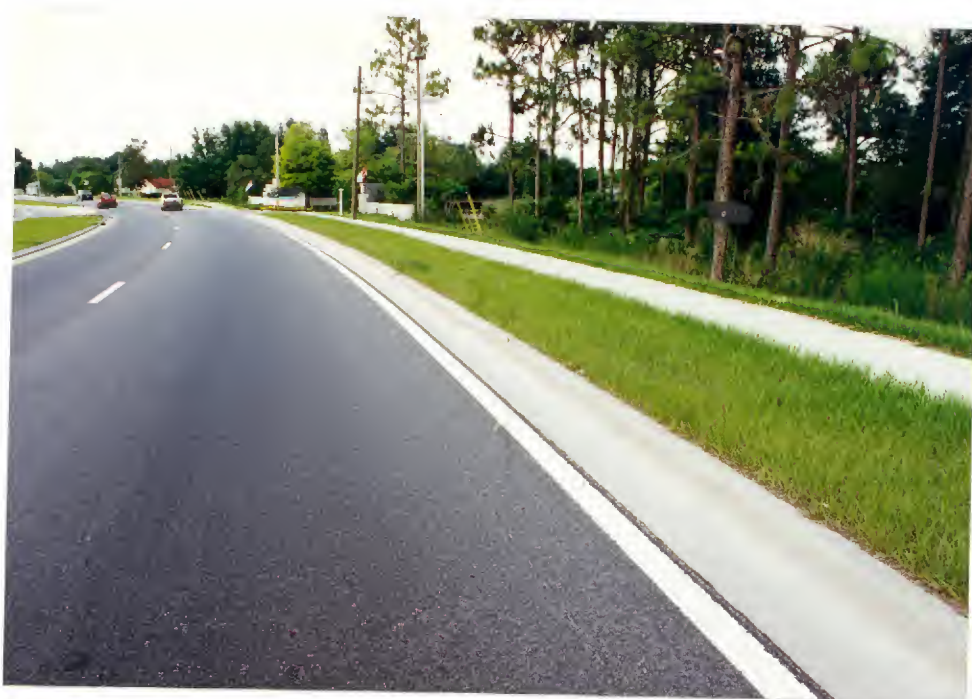
5. Remainder of the right rear tire mark on the road surface.

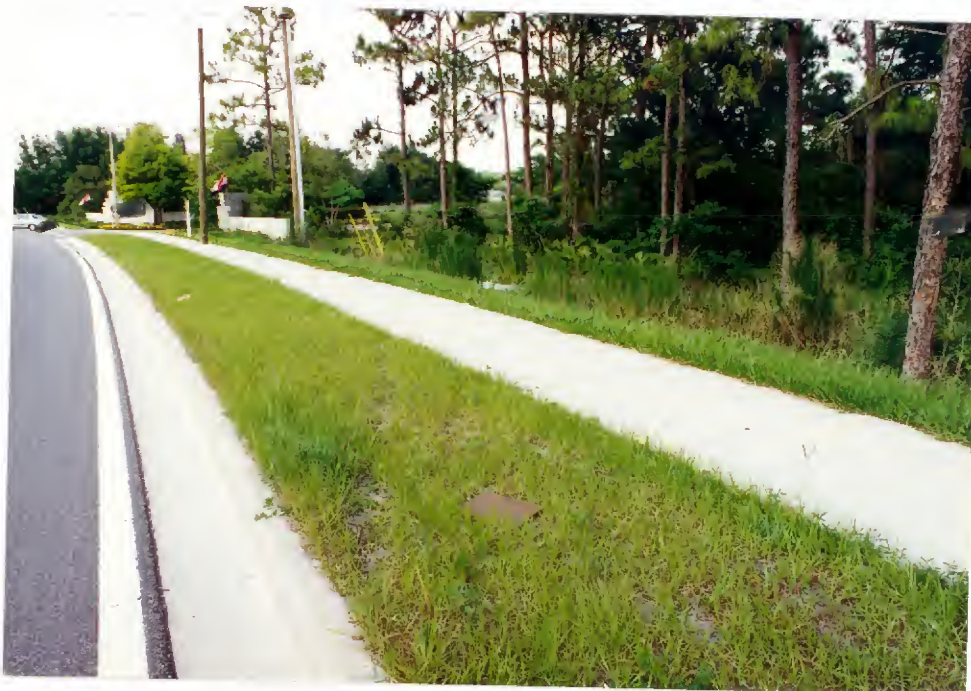
6. Hyundai mounts barrier curb and traverses grassy area and sidewalk in a CW yaw.

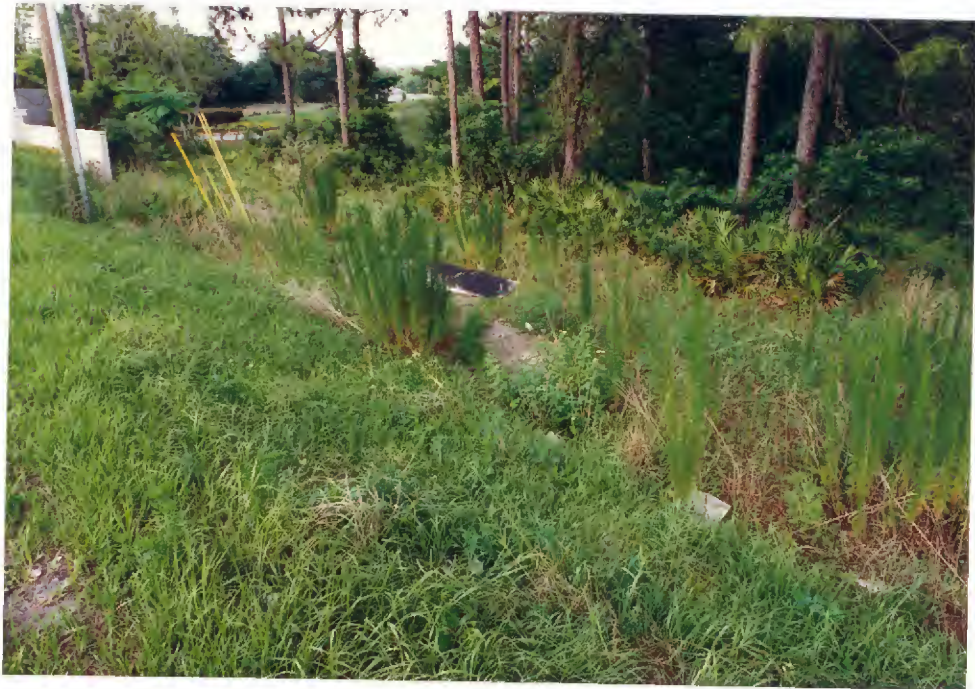
7. Vehicle traverses embankment leading with left side.

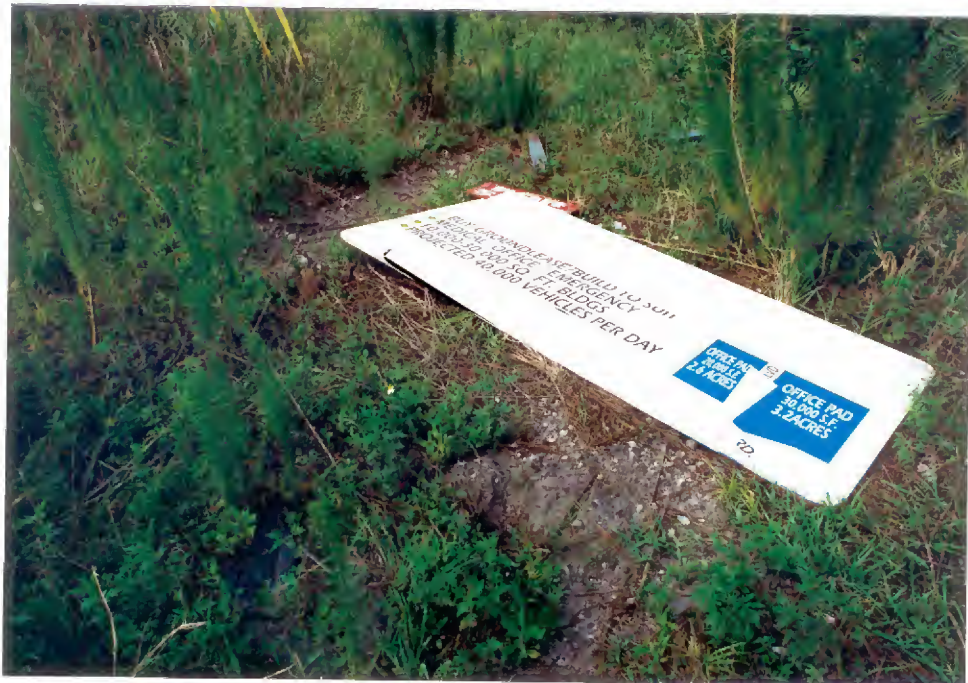
8. 1.2 x 2.4 m (4 x 8') sign struck by left side of vehicle.

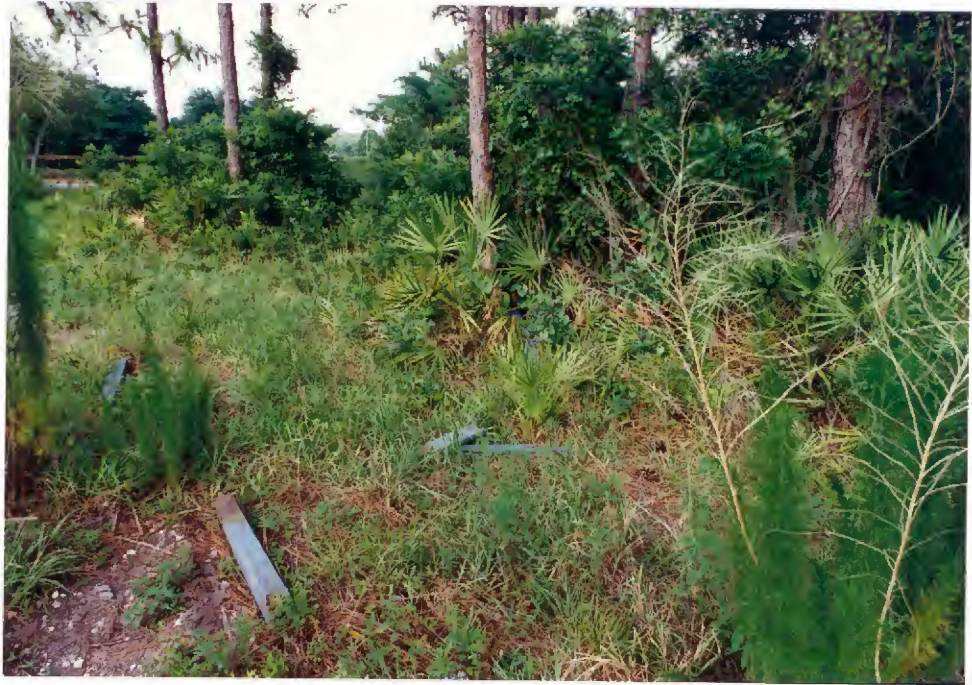
9. Fractured 10 x 10 cm (4 x 4") wooden sign posts.

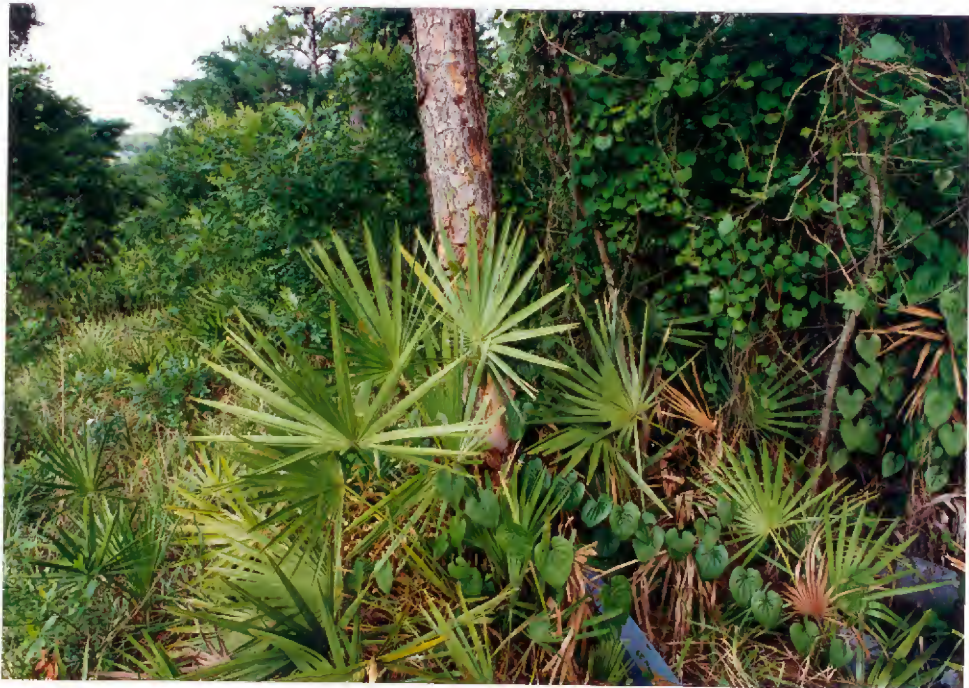
10. Struck 23 cm (9") diameter tree.

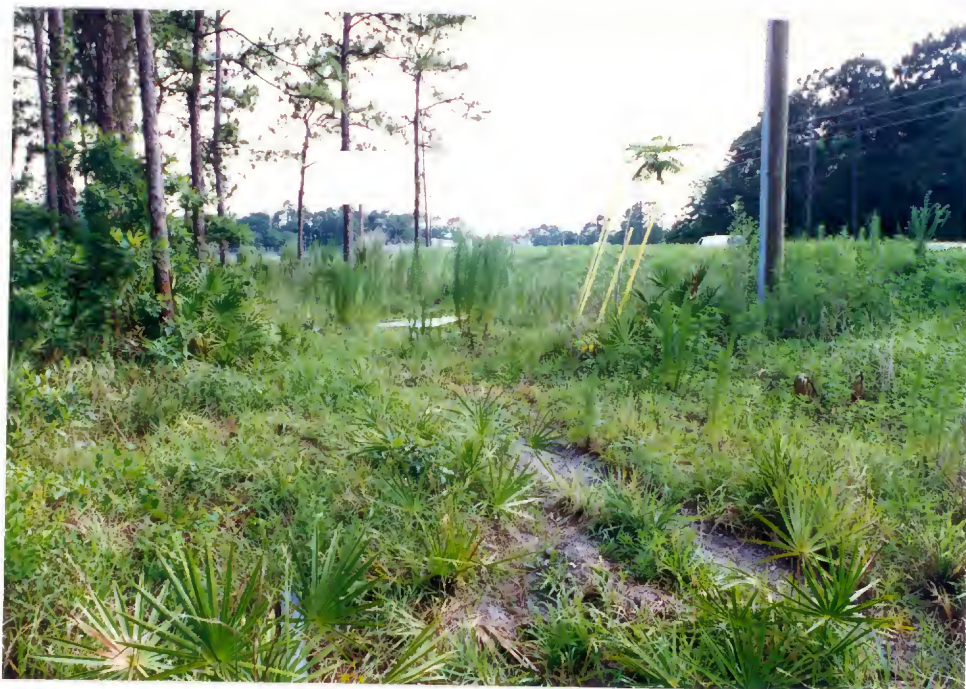
11. Vehicle's final rest position in foreground and lookback view of overall trajectory.

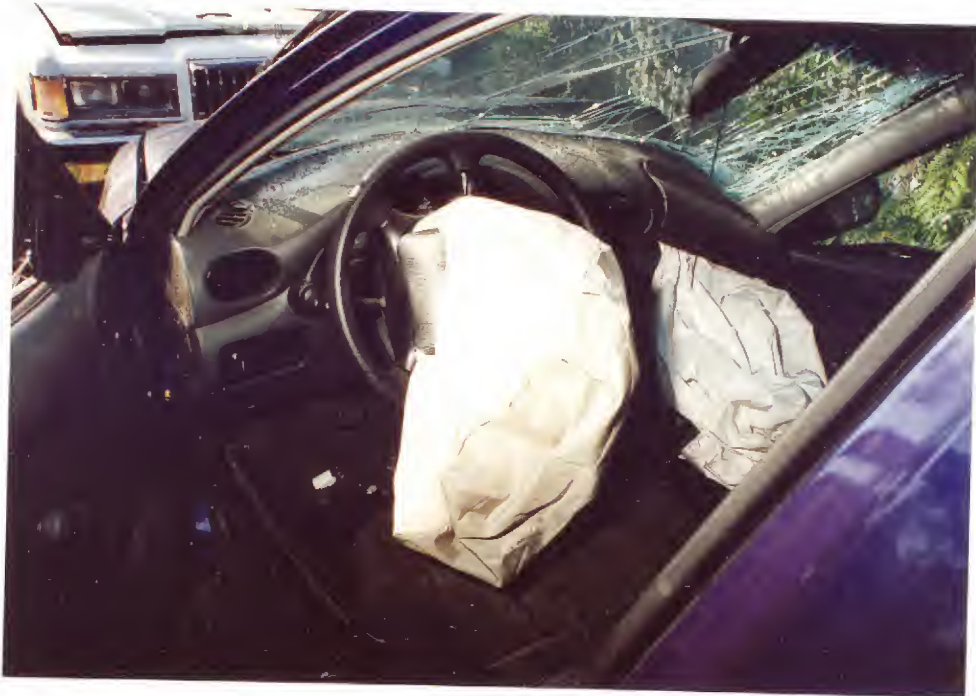
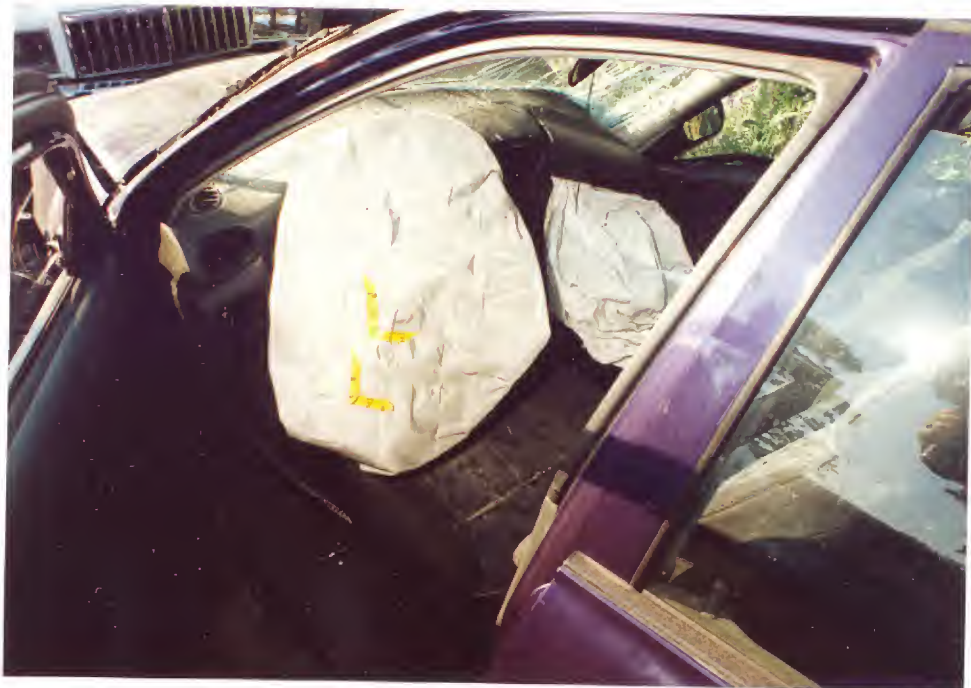
The supplemental driver and passenger side air bag system deployed as designed from the respective module assemblies. The driver's face contacted the deployed driver's side bag as evidenced by lipstick transfers on the face of the bag. The passenger side air bag fabric expanded against the rearward facing child restraint. As a result of expansion against the infant restraint, fabric transfers were present on the bag fabric from the lining of the infant restraint. There was no damage to the air bag fabrics.

29. & 30. Overall views of the vehicle's interior and the deployed air bags.

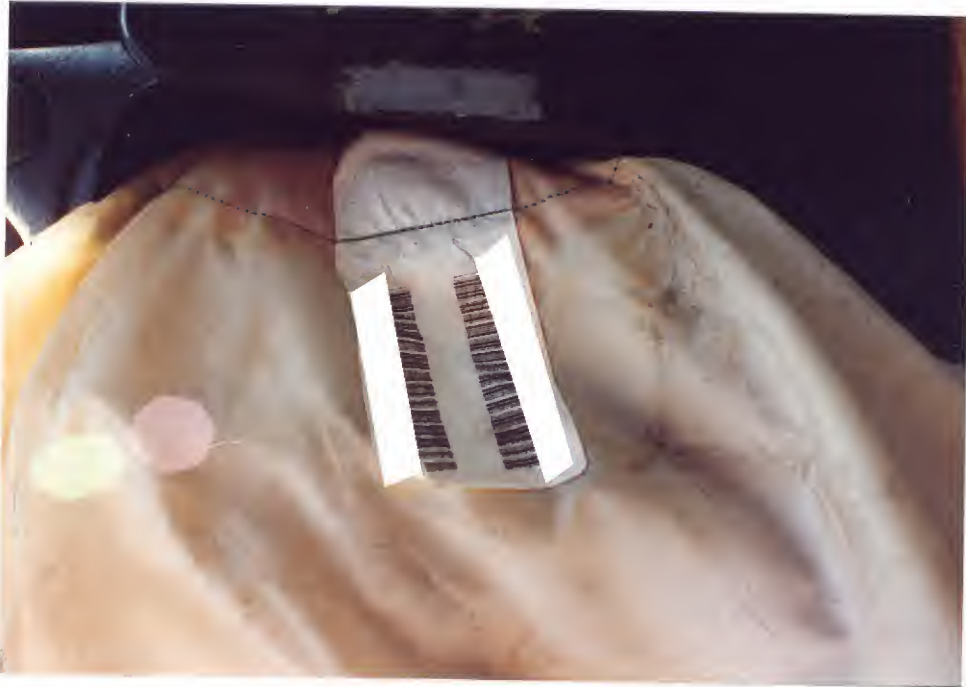
33. Bar-coded identification label affixed to the driver's bag at the 12 o'clock position.

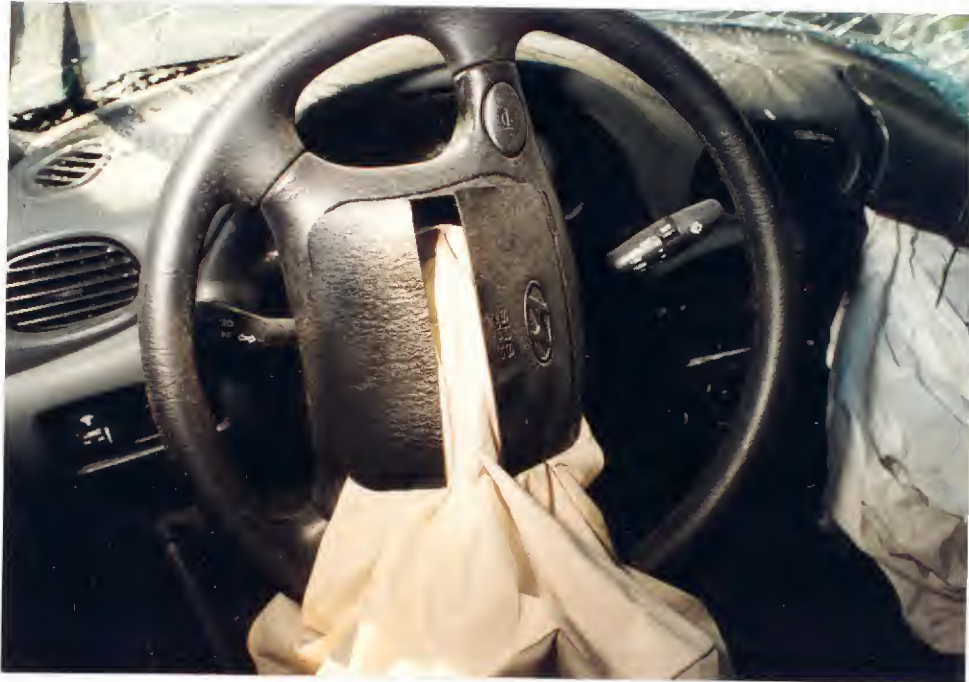
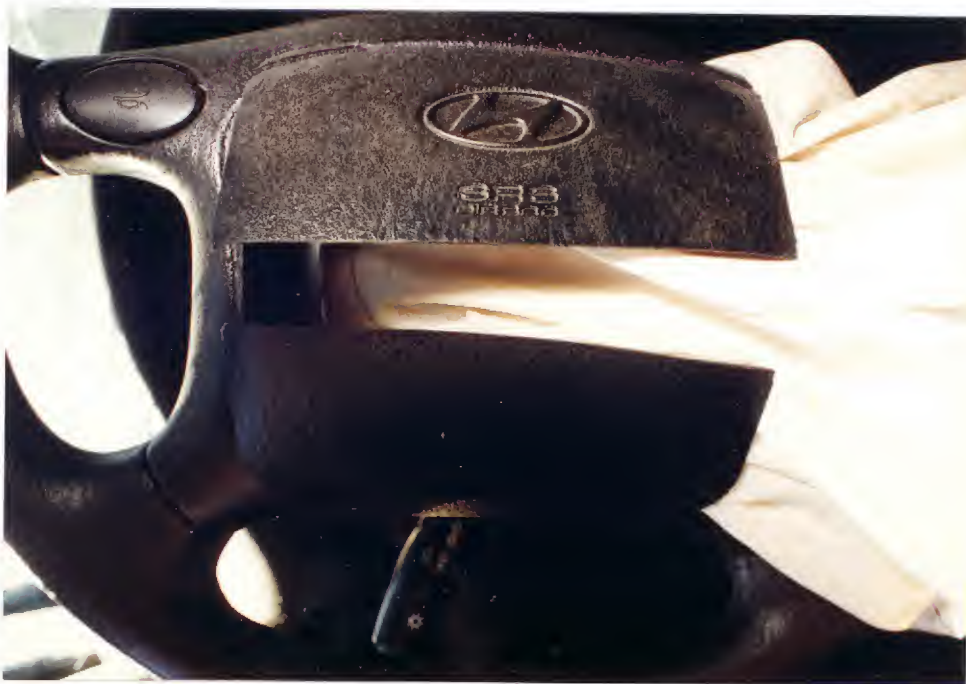
35. & 36. Close-up views of the module cover flaps.

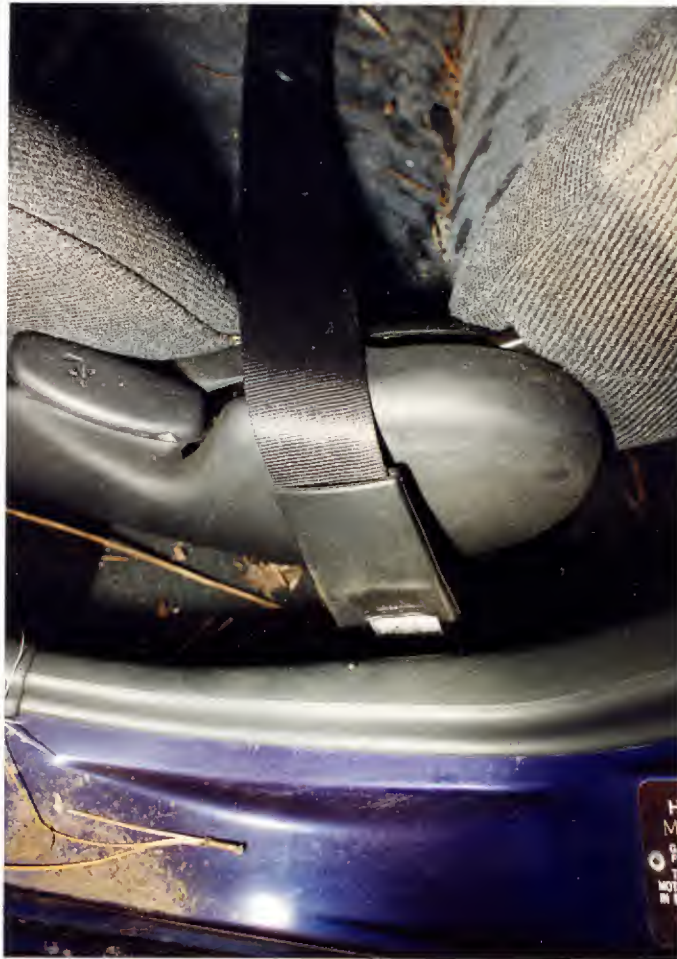
41. Intact energy management loop of the driver's side belt system.

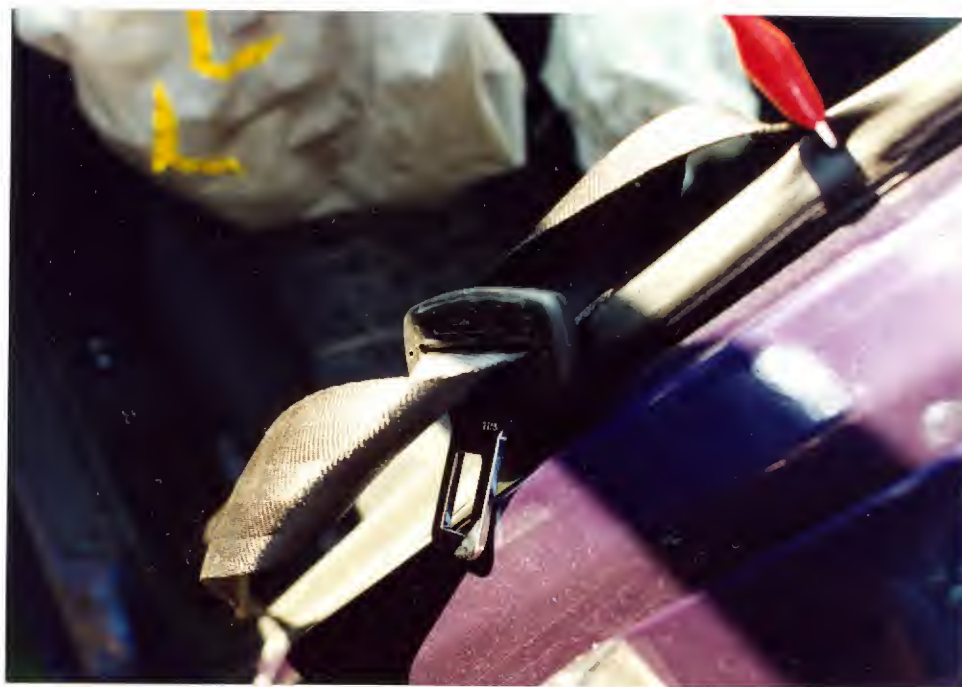
the polymer covering of left front latchplate was abraded from belt interaction (driver loading) against the latchplate (refer to Photograph Nos. 43 and 44). Minimal routine wear marks were noted to the male tab of the latchplate.

43. Belt webbing abrasions to the plastic latchplate cover.

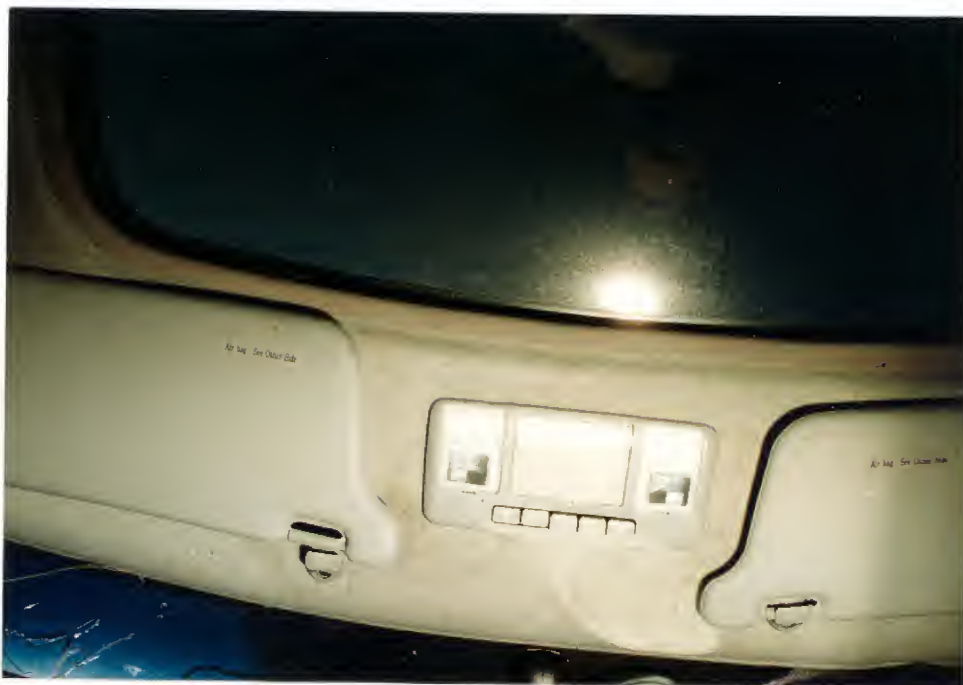
46. Air bag advisories on sunvisors.

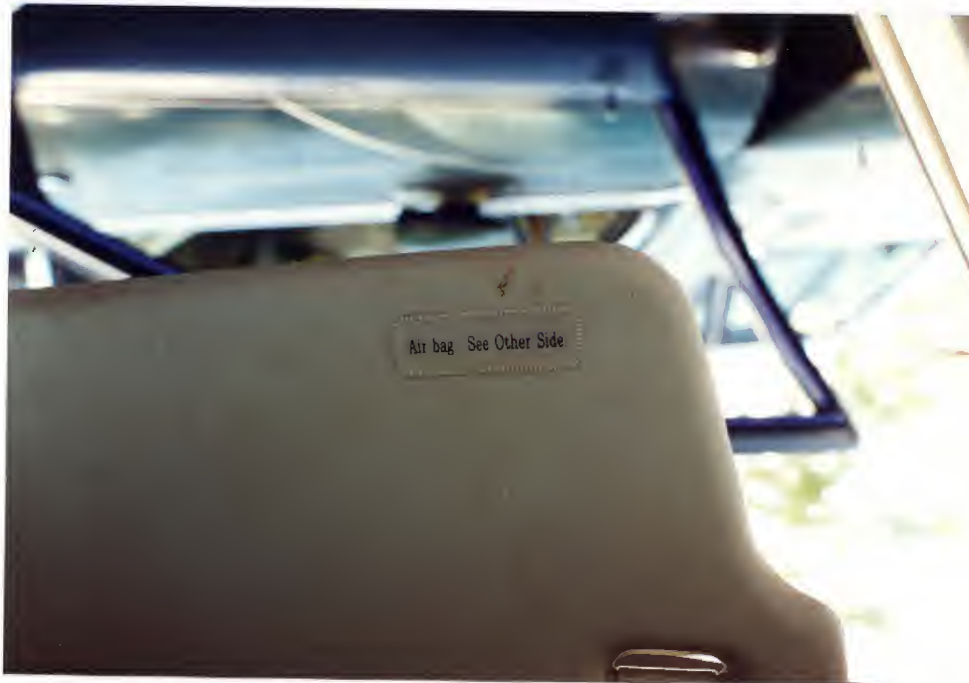
Air bag advisory labels were affixed to the sunvisors. On the bottom (exposed) side of the visor, at the rear inboard corner, was a label that measured 5.1 x 1.3 cm (2.0 x 0.5") which noted the following (refer to Photograph No. 47): **Air Bag. See Other Side.**

47. Close-up view of the advisory label

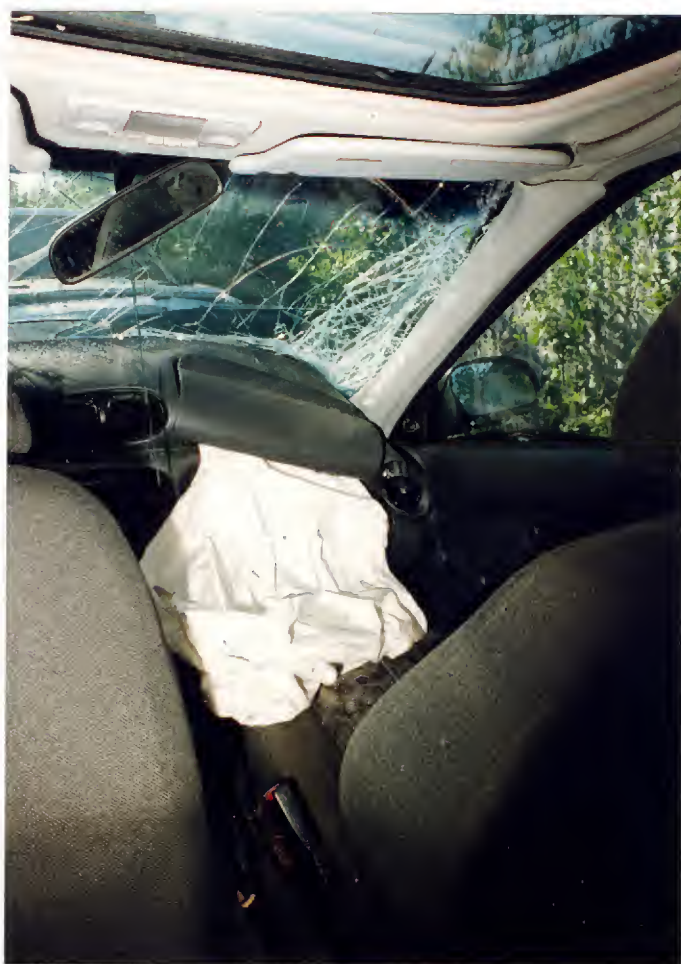
There was no damage to the passenger side air bag and/or the module cover assembly, however, fabric transfers from the rearward facing child restraint were noted to the upper aspect of the bag. A vertically oriented red fabric transfer was located 2.5-12.7 cm (1.0-5.0") below the upper seam (refer to Photograph No. 56). A faint blue fabric transfer was located 14.0-20.3 cm (5.5-8.0") left of the bag's centerline and 5.1-21.6 cm (2.0-8.5") below the referenced seam.

50. Overall view of the deployed passenger side air bag.

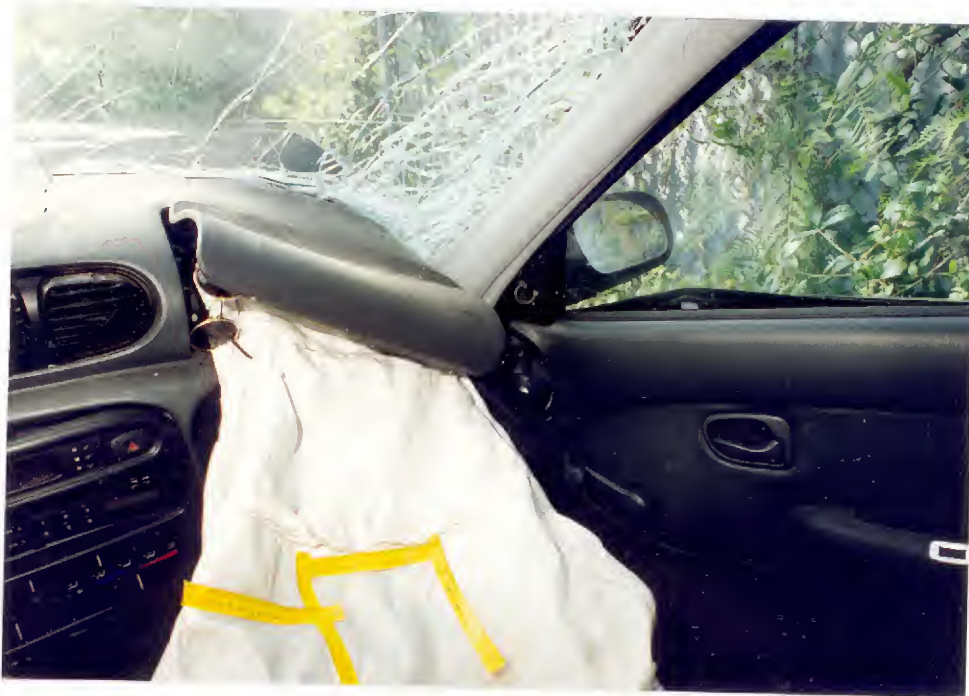
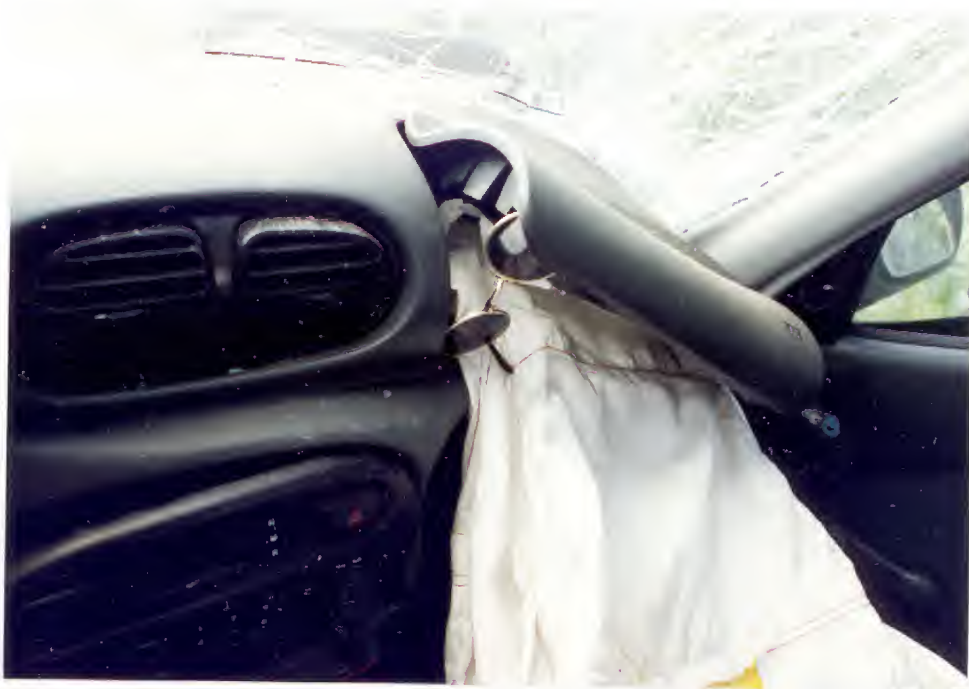
51. & 52. Views of the location and contour of the passenger side air bag module cover flap.

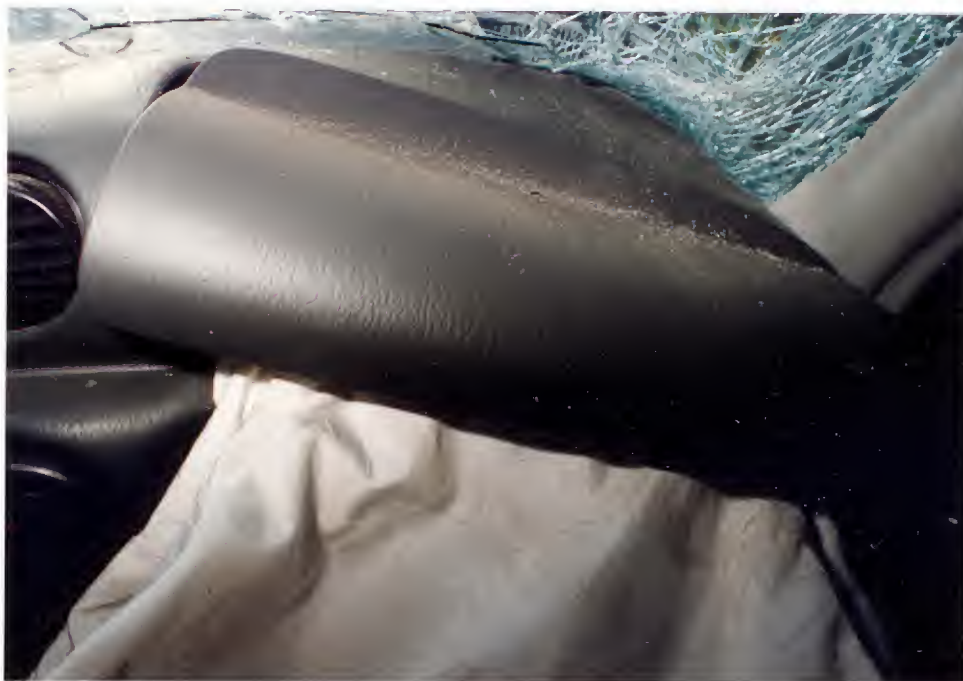
54. Leading edge of the passenger side module cover flap.

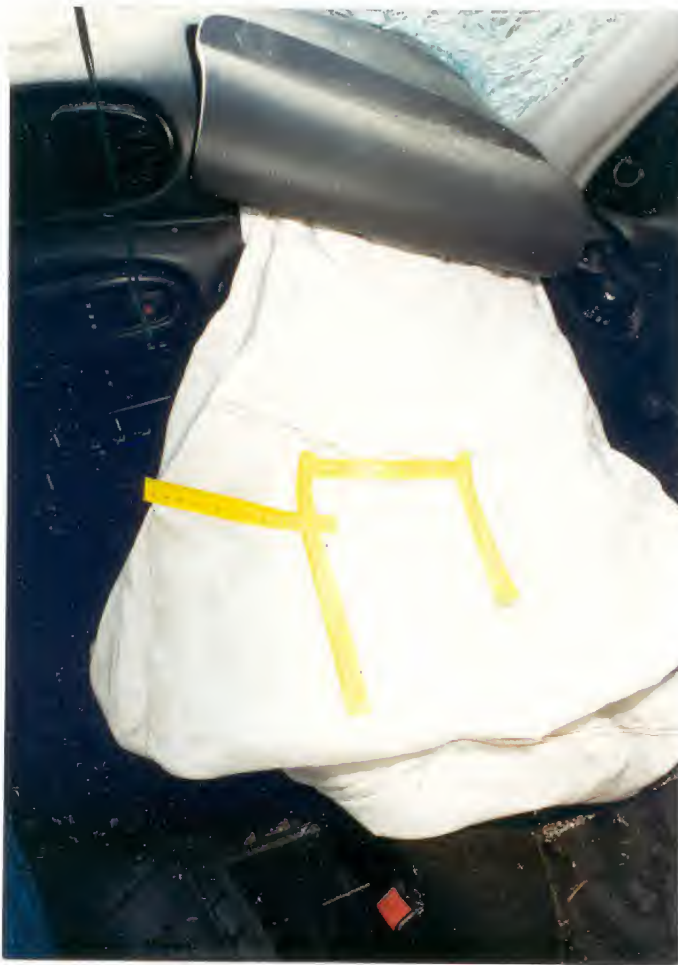
55. Overall view of the top of the deployed passenger side air bag.

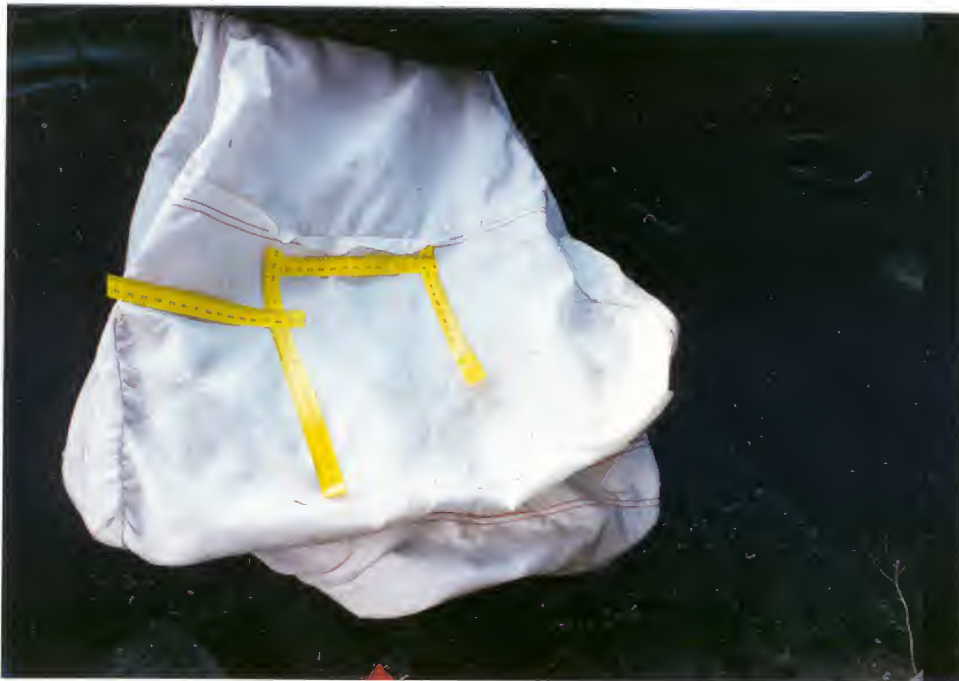
56. Probable fabric transfers from the rearward-facing child restraint.

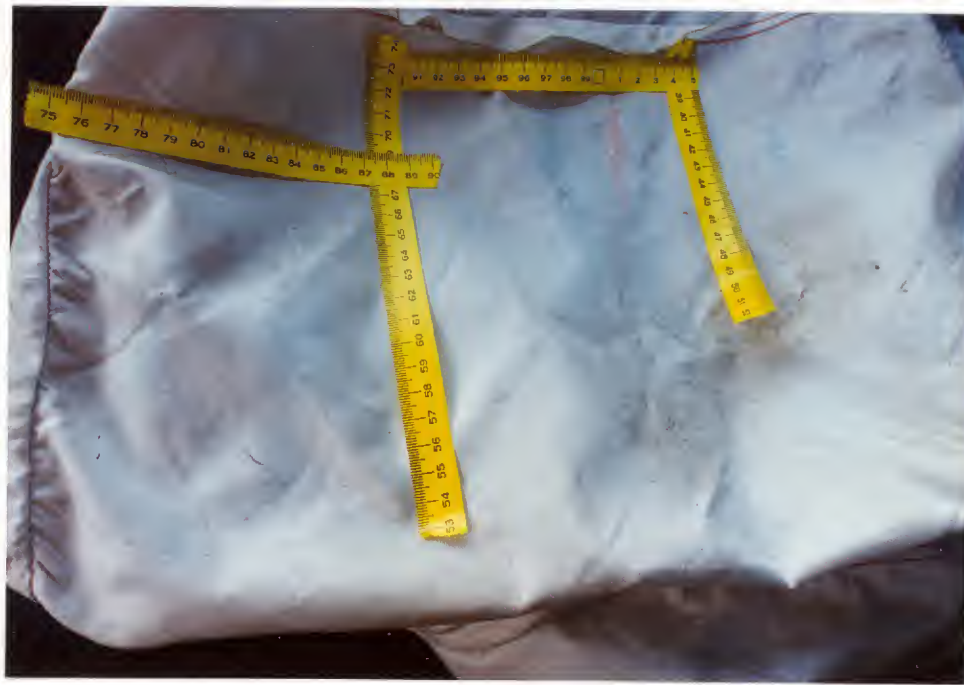
57. Close-up view of the probable fabric transfers.

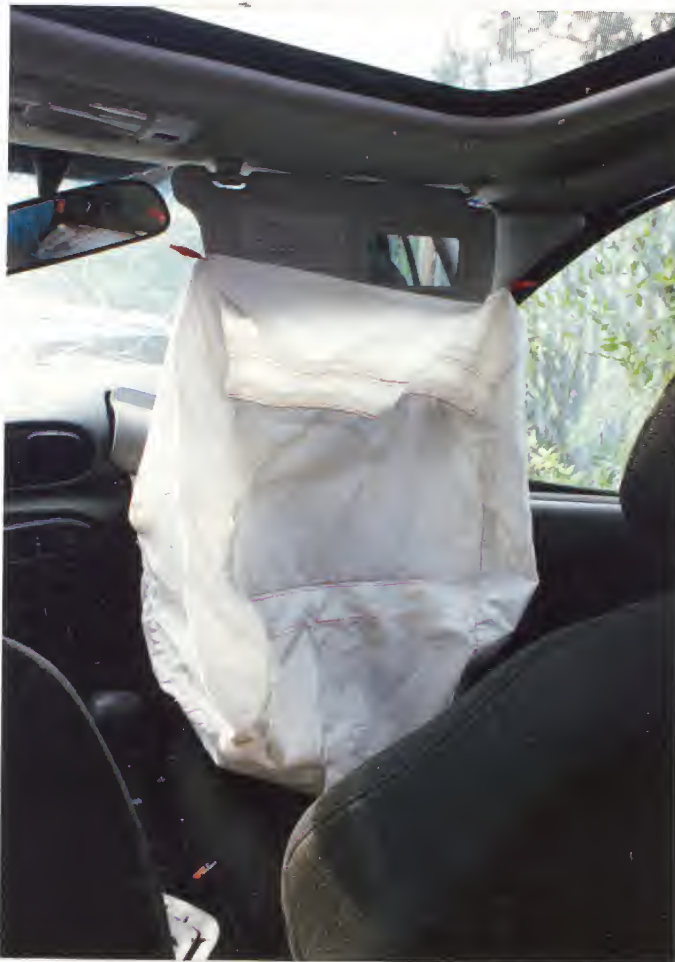
58. Horizontal tether seams on the face of the passenger side air bag.

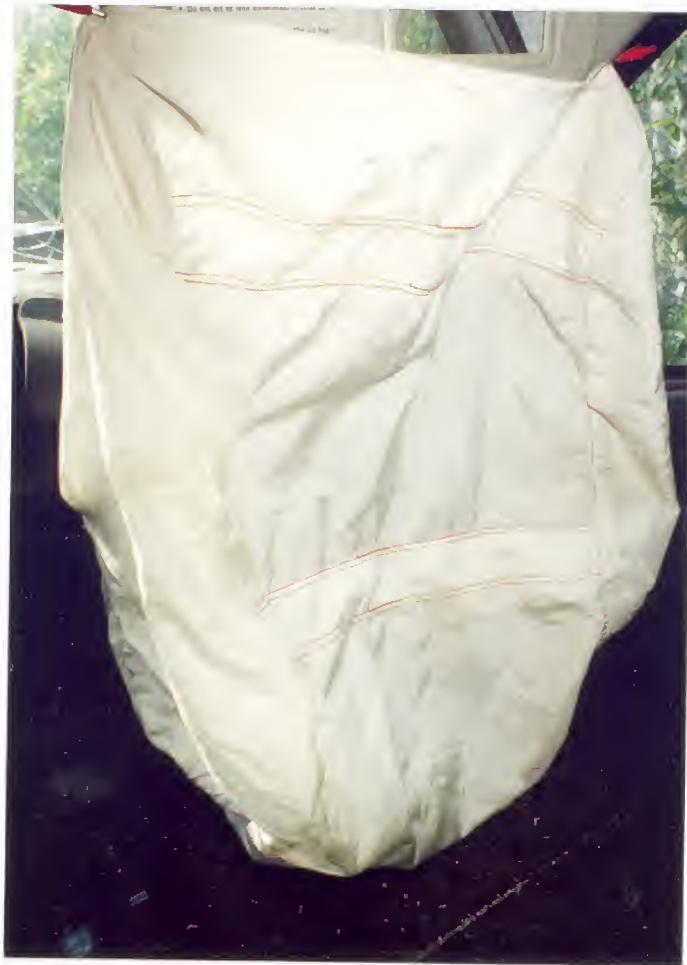
59. Additional view of the tether seams.

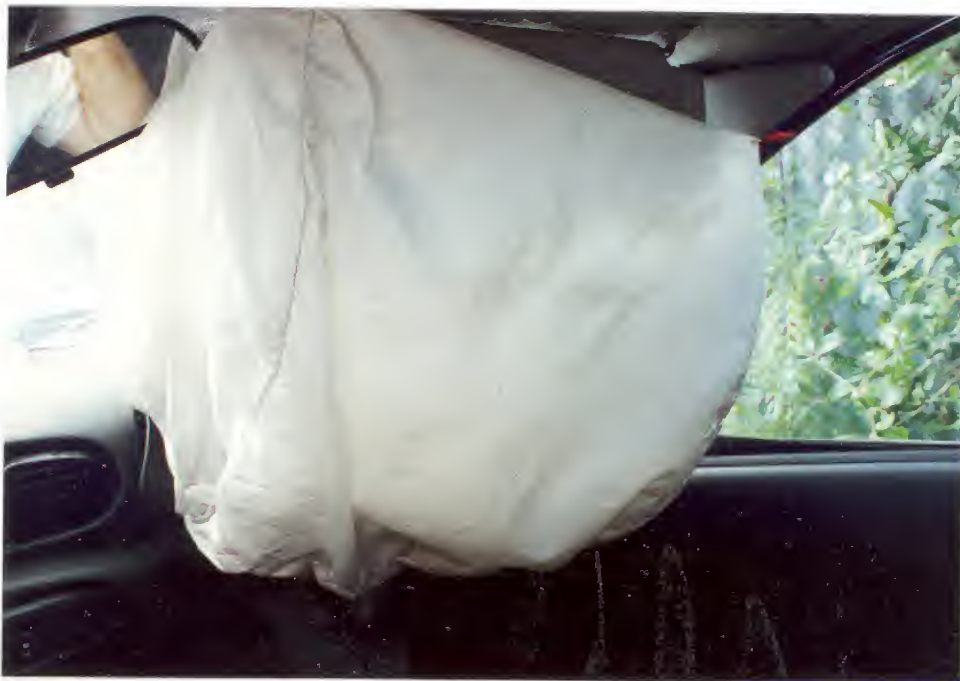
60. Underside of the passenger side air bag.

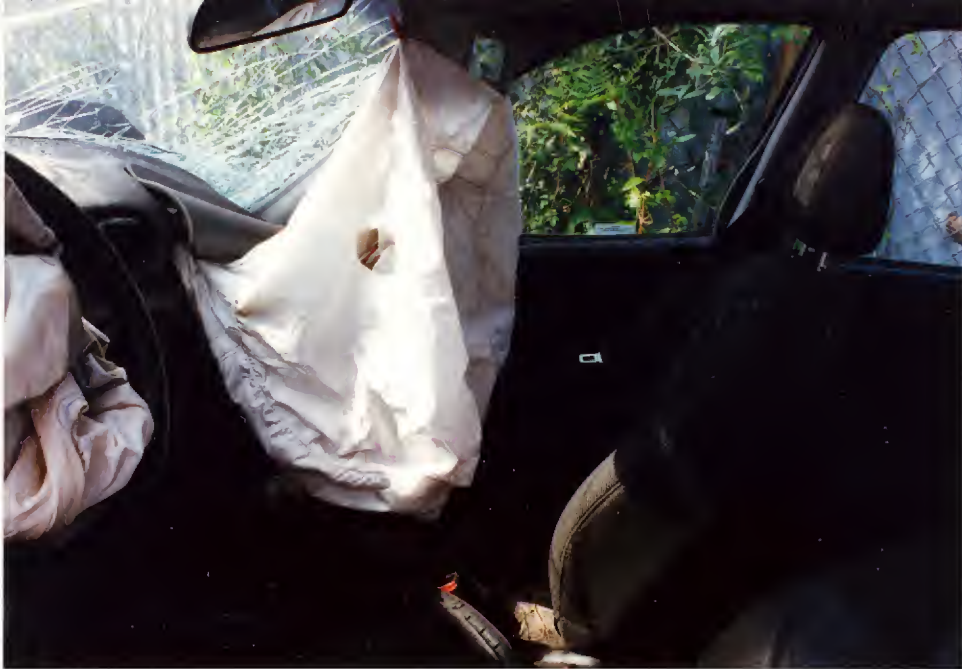
61. Perpendicular view of the deployed passenger side air bag.

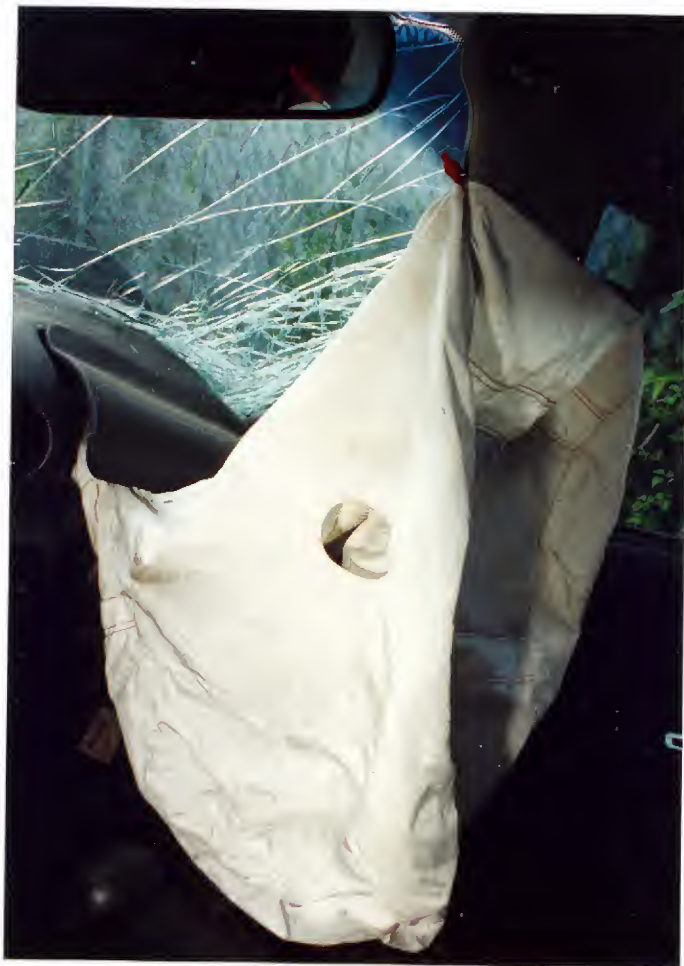
62. Inboard 5.1 cm (2.0'') diameter vent port.

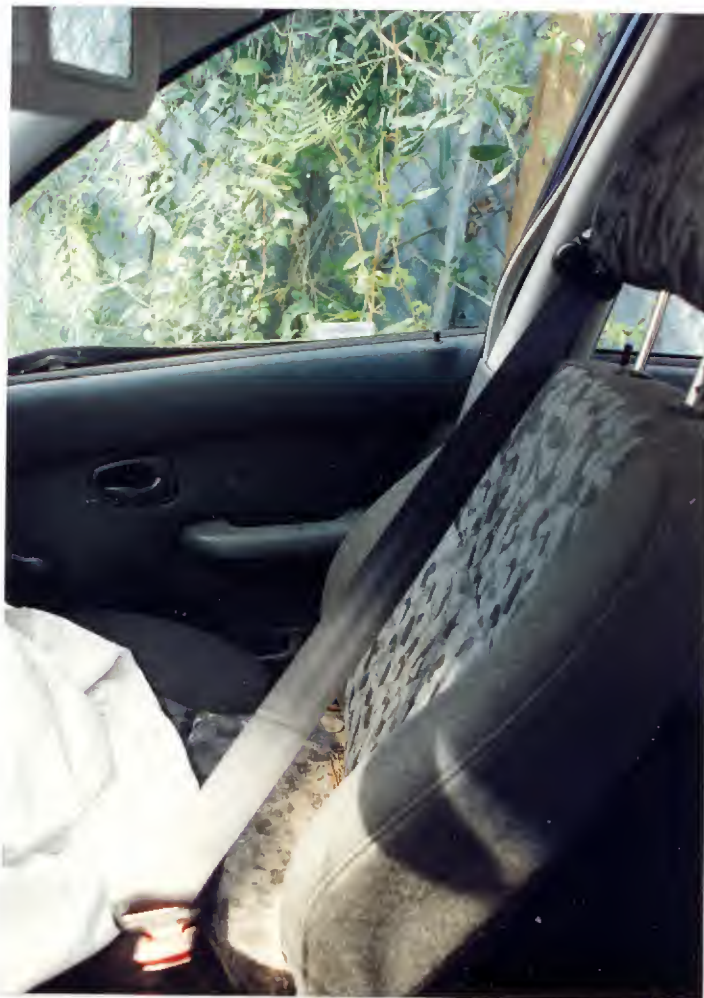
64. Extended passenger side shoulder belt webbing.

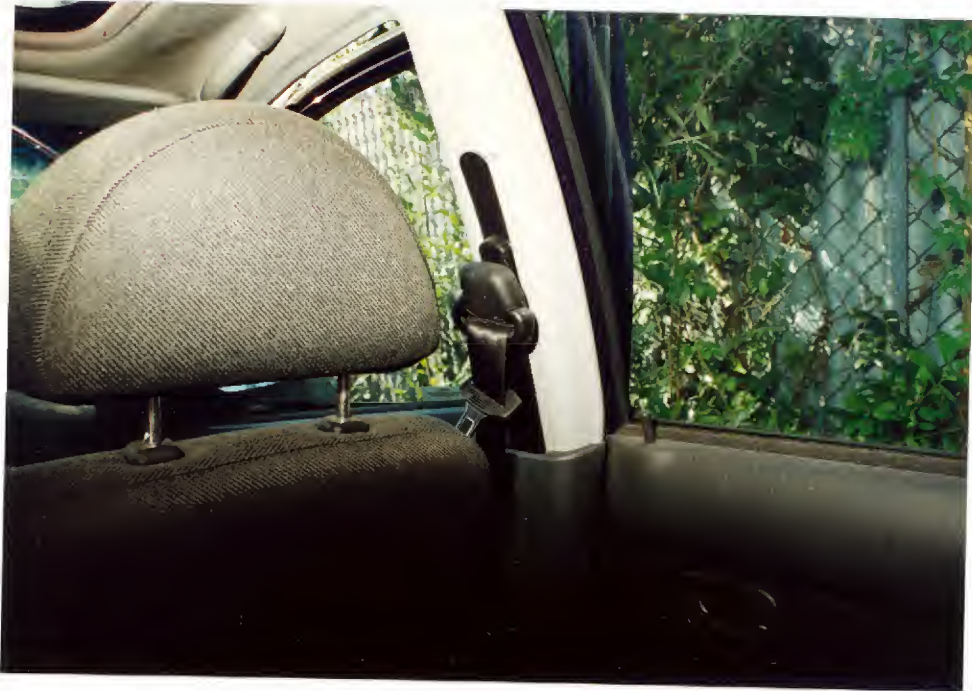
65. Adjustable upper anchorage (D-ring) of the passenger side belt system.

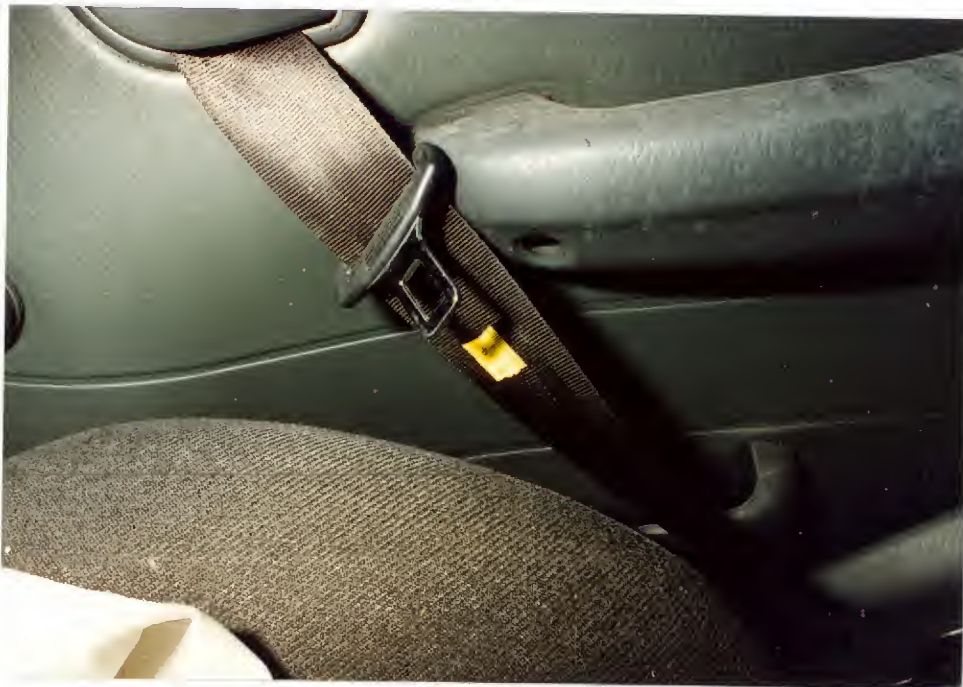
66. Probable air bag fabric transfer on the right front shoulder belt webbing.
